# Mechanical, Electrical, Plumbing and Fire Protection Existing Conditions Narrative for MV Regional High School

Martha's Vineyard Public Schools  
Oak Bluffs, Massachusetts

March 26, 2021

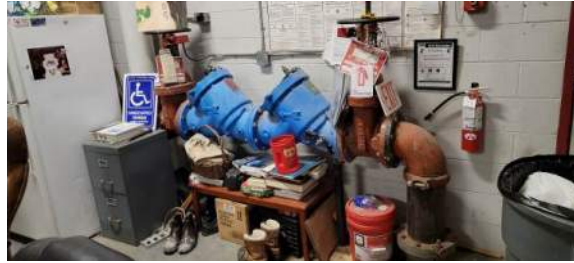
**6" Service in portion of building constructed in 1990s**

**8" Service in portion of building constructed in 1990s**

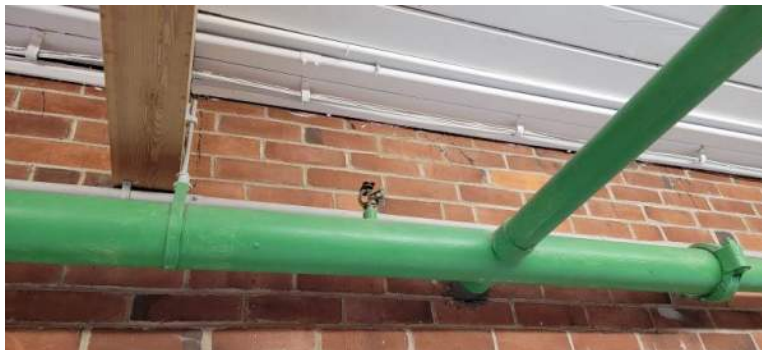
2. The School is protected by varies types of sprinkler heads. Which range from uprights, sidewalls, & semi recessed. Along with a mixture of Fuse Link & Bulb style sprinkler heads. It is recommended that all Fuse link sprinkler heads to be replaced with quick response sprinkler heads.
3. In the original portion of the school the school is mostly exposed wood beams, with exposed mains & branches with fuse link uprights or sidewall sprinklers.

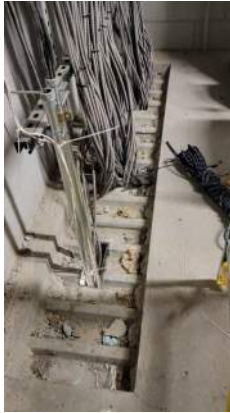
4. In the two (2) additions from 1980s & 1990s the classrooms & Corridors have ACT ceilings and are protected with Semi Recessed sprinkler heads.
5. Existing Electrical room with Mechanical Mezzanine room above is currently protected with fuse link upright sprinkler heads, no sprinkler heads are located in the Electrical/Data room below. There is no 2-hour rated separation between rooms and upright sprinkler heads should be added to space below for proper coverage.

- a. It is recommended to seal the Mezzanine slab, in an event that a sprinkler head goes off in the Mechanical room above. Water will flow down these unsealed openings directly on top of the electrical equipment below.

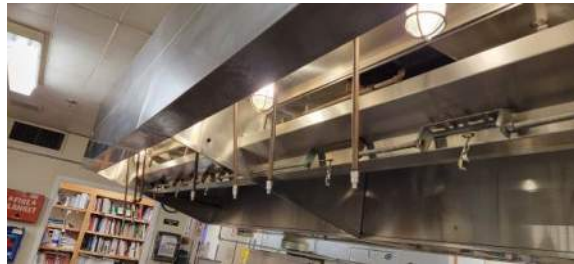
6. Both the Main Kitchen & Culinary Kitchen hoods are protected with an Ansul System.

**Culinary Kitchen hood**

**Main Kitchen Hood**

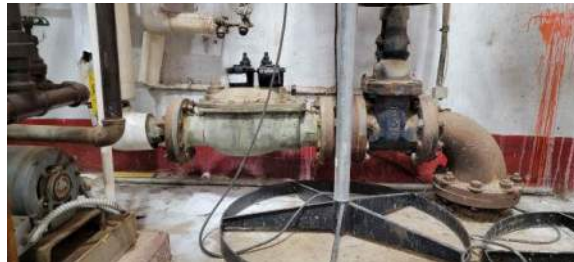
1. This School is supplied by Town water from two (2) domestic water supplies. One is believed to feed the original school along with the 1980s addition, as the other is believed to feed the 1990s addition of the Gym (locker rooms, showers, gang bathrooms), PAC (Performing Arts Center), & some classrooms. It is recommended to add a full-sized reduced pressure backflow preventor to each service to protect the town & the school's water from possible backflow.

**6" service reduced down to a 4" water meter with no Reduced pressure backflow preventor. located within the original school's mechanical room.**

**4" service reduced down to a 3" water meter with no Reduced pressure backflow preventor. located in exterior access Mechanical room in 1990s addition**

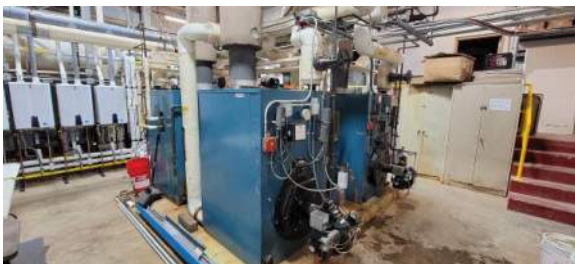
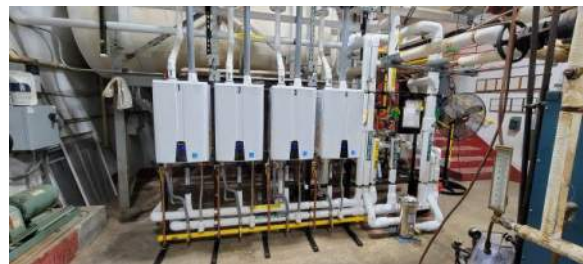
- d. Currently there is some issues with the installation which have led to the main boilers to not be used for the domestic hot water, and only the instantaneous water heaters are creating hot water for the school. It is recommended the piping between the piping from the boilers, water heaters & Storage tank be re-piped with proper isolation valves to allow change over of systems depending on the season.

**Main (4) Boilers in 1959 Mechanical room      (4) Instantaneous water heaters with 1,000 Gallon Storage tank behind**

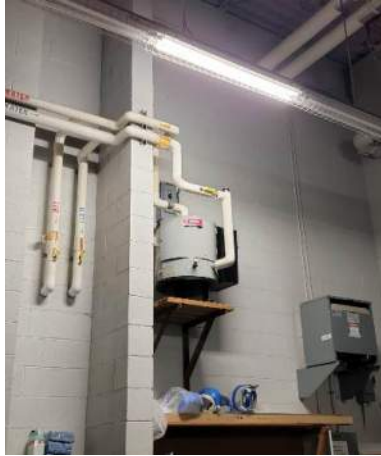
**Small Electric water heater feeding  
Custodial area near 1990s Mechanical room**

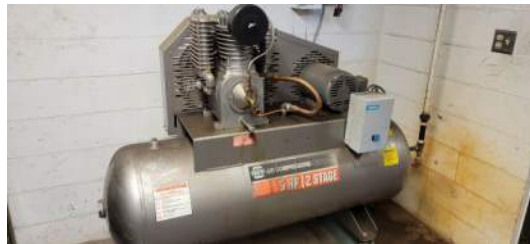
1. Automotive shop compressed air system is currently supplied by a 5HP 2 stage air compressor that is at the end of its life, and is slated to be replaced in the near future.

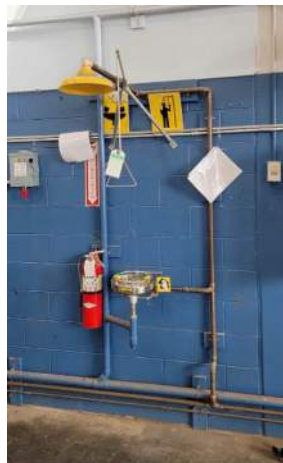
2. Emergency eyewash & shower combo located within the automotive shop. It appears to be feed from a cold-water supply with no mixing valve. The eyewash drain is hard piped. No floor drain provided for shower.

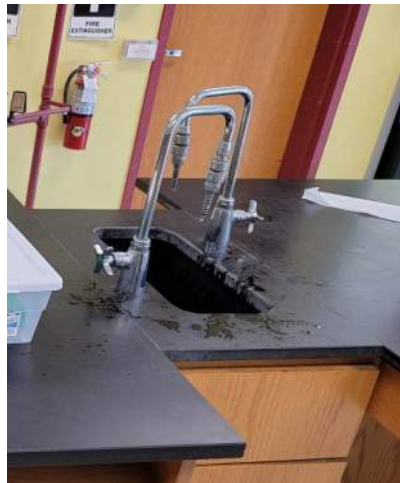
3. Science Classrooms include sinks without vacuum breakers. There are no cross-control devices. The main water lines may be subject to backwater conditions that would contaminate the piping system without backflow prevention.

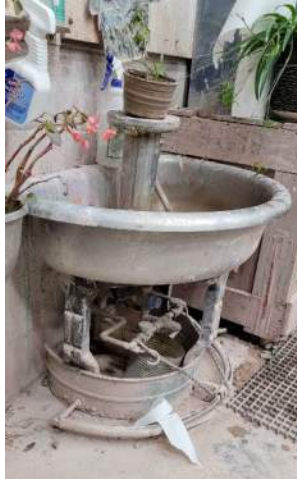
1. The sink located in the art class room is a multi-person use foot operated stainless-steel sink. Giving its location & use it is required to have a paster trap to protect the sanitary system from debris.

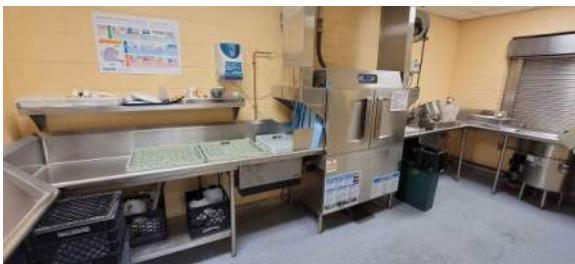
3. Main kitchen has commercial grade dishwasher provided with electric booster heater, and food disposal system. no grease interceptor was found to be associated with this dish washer.

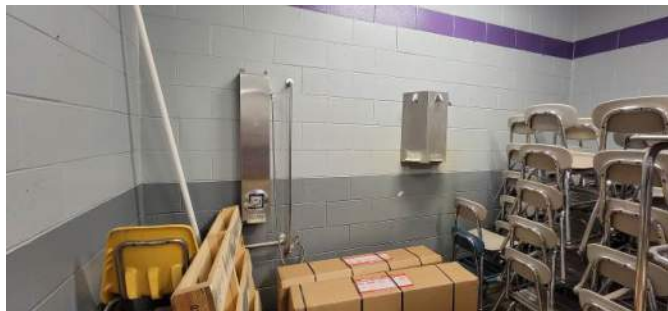
1. The Boys' and Girls' shower rooms have not been used in many years and are currently being used for storage. The Boys' showers are of the gang arrangement. The main mixing valve that feeds both shower rooms is currently turned off.

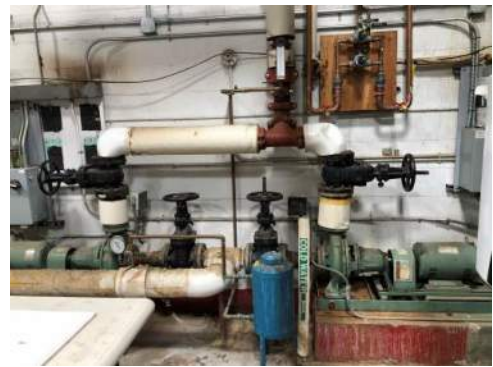
The pumps are equipped with variable frequency drive (VFDs). The VFDs have been placed in hand mode and do not react to system pressure changes in the system.

### **Base Mounted Pumps**

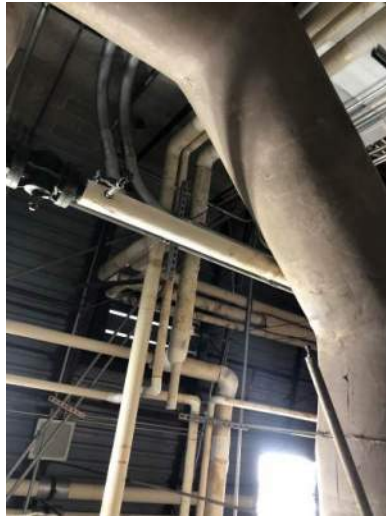
**Combustion Air Intake**

Combustion air is brought into the building by a roof mounted intake hood. With a short section of ductwork to house a damper. Today's code requires ductwork with a lower opening at 12" above finished floor and a high

opening at the ceiling level. The combustion air intake does not meet today's code.

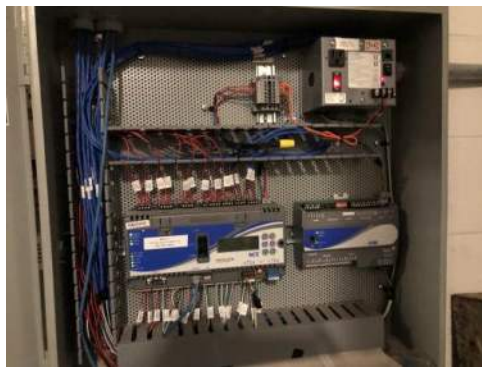
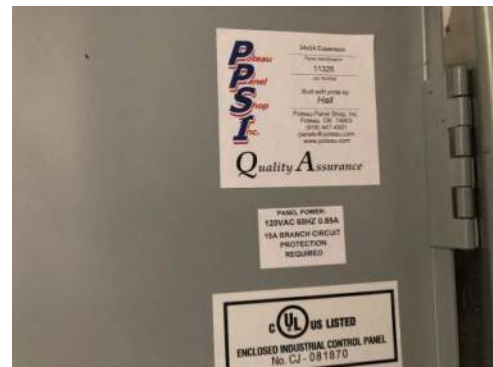
## Automatic Temperature Control Panel

The building management system is Metsys by Johnson Controls. The building is direct digital control meeting today's standard for building controls. However hot water coils are still equipped with 3-way valves which prevent taking advantage of the pumps VFDs. Recommending to replacing 3-way valves with 2-way valves which will allow the system to adjust pump flow based on maintaining system pressure. Matching the building load will save energy. The current valving arrangement constantly flows heating hot water either through the coil or away from the coil if the space is satisfied. The flowing away from the coil is the wasted energy. With a 2-way valve the coil would be closed to the system. The system would see a rise in pressure and slow the pumps down to bring the system back to set pressure. Using less pump energy and less boiler energy.

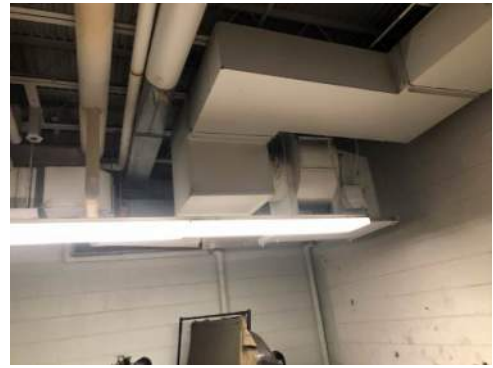
### **Vehicle Exhaust Capture System**

The automotive shop is equipped with vehicle exhaust capture system. The ports are located in the floor with flap covers to prevent debris from getting into the system. The ductwork runs below the slab to a duct riser and exhaust fan exiting the building at the mezzanine level of the shop.

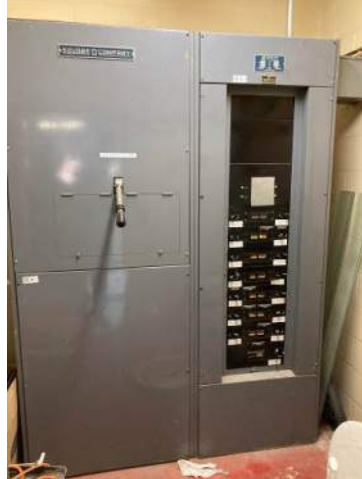
**Switchboard 2**

The switchboard as manufactured by Square D is rated for 120/208v, three phase, four wire, 1200 amp and has a 1200/3 main breaker, which has issues to be opened as there is a cover plate which does not open properly, and branch panel breakers. The switchboard appears to be original to the building and is in fair to poor condition.

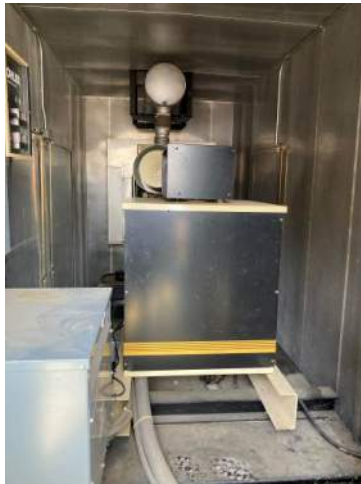
**Interior of Enclosure**

The building has a 277/480-volt, three phase, four wire, 100 kW diesel generator as manufactured by Kohler is located in an exterior stand-alone building, adjacent to the Main Electric Room. The generator has a 225/3 circuit breaker on it which feeds the emergency side of the automatic transfer switch located in the enclosure. The automatic transfer switch as manufactured by Kohler and is rated at 260-amp, 277/480-volt, three

phase, four wire. The load side of the automatic transfer switch feeds the emergency distribution panelboard EDP, also located in the generator enclosure. Panelboard EDP feeds adjacent panelboard EL via a transformer, both of which are located in the generator enclosure, panelboards B-H, PP-B, LP-B, KP-B, as well as AHU's 8 and 10. These panelboards feed mixed emergency loads including both optional standby and emergency circuits. There are numerous emergency system deficiencies as it relates to current Codes. There is only one automatic transfer switch which controls both emergency life safety and optional stand by loads. Emergency panelboards need to have dedicated two hour rated emergency electric rooms and cannot share space with optional standby and normal panelboards. Emergency panelboards require two-hour feeders such as MI Cable and are required to be housed in two-hour electric rooms. Emergency panelboards have to be dedicated to emergency loads and cannot feed optional standby loads within the same panelboard. The emergency power distribution appears to be original to the building and the installation as it relates to today's Codes is poor. Also, there was 3-4 inches of water in the bottom of the generator enclosure which is a hazard to staff as well as the equipment. The generator system is in poor condition.

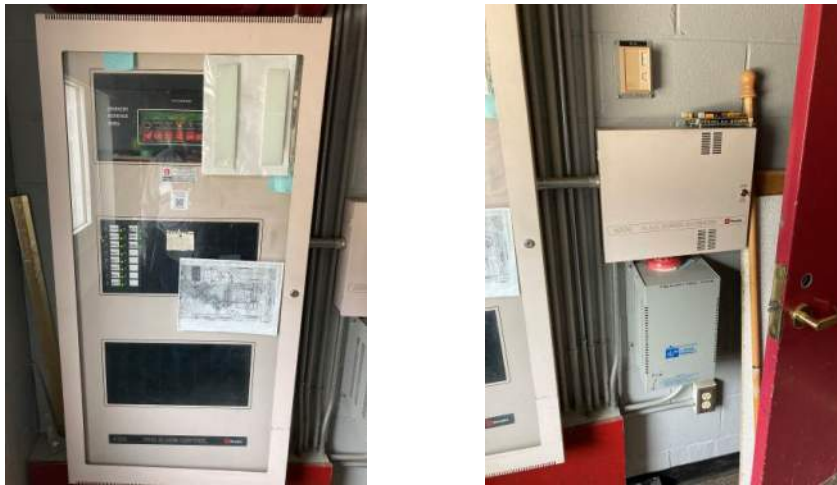
The addressable fire alarm control panel as manufactured by Simplex series 4100, is located in the Janitor's Office. The panel is not setup as a voice evacuation panel, there is no microphone and no drill switch. There are no annunciators located at the entrance vestibules. There is one exterior mounted knox box located near the main entrance to the building. There are duct smoke detectors on Mechanical equipment. There are no speakers in the building, horn/strobes. The Toilet rooms do have strobes as required by ADA. There is no carbon monoxide detection in the Day Care Room where children presumably take naps. Local sound systems do not have the capability to shut down upon fire alarm activation. Most of the fire alarm system appears to be original to the building and is in poor condition.

Fire Alarm Control Panel and Notification Device

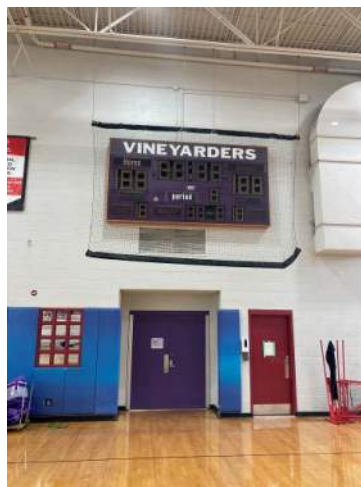
**Scoreboard**

The Gymnasium has a wired scoreboard and two shot timers. The Gymnasium lighting appears to be in fair condition. Scoreboard/shot timer system appears to be original to the building and is in poor condition.
