# Mechanical, Electrical, Plumbing and Fire Protection Existing Conditions Narrative for MV Regional High School

Martha's Vineyard Public Schools  
Oak Bluffs, Massachusetts

March 26, 2021

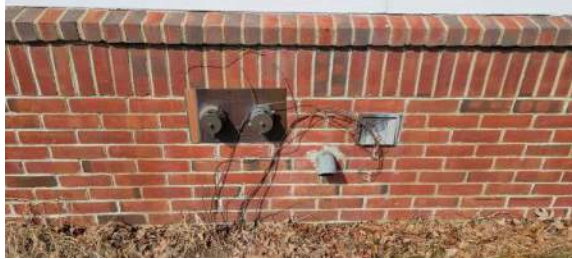
**Each Fire service is provided with (2) 2 ½" FDC connections.**

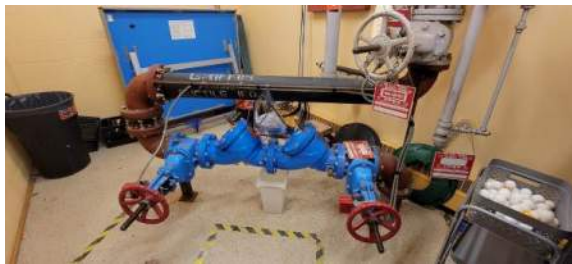
**Original 6" Service in portion of building constructed in 1959**

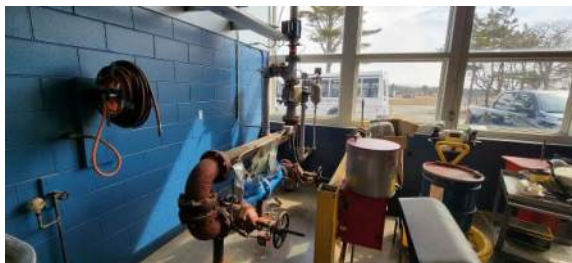
**6" Service in portion of building constructed in 1980s**

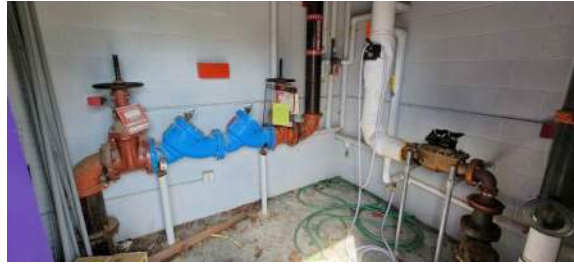
**6" Service in portion of building constructed in 1990s**

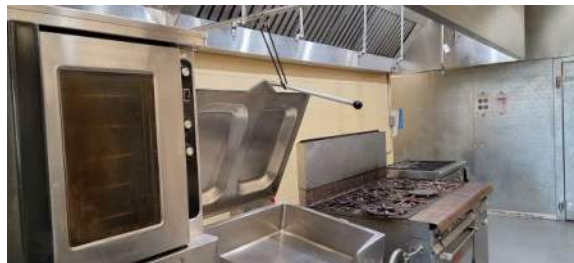
**Main Kitchen Hood**

6. Both the Main Kitchen & Culinary Kitchen hoods are protected with an Ansul System.

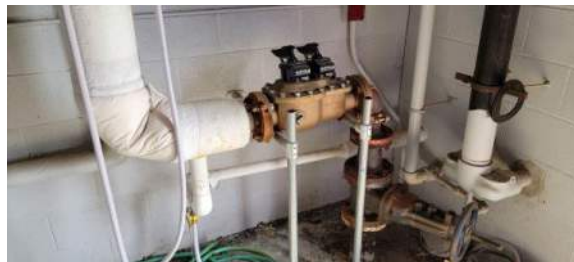
**4" service reduced down to a 3" water meter with no Reduced pressure backflow preventor. located in exterior access Mechanical room in 1990s addition**

1. This School is supplied by Town water from two (2) domestic water supplies. One is believed to feed the original school along with the 1980s addition, as the other is believed to feed the 1990s addition of the Gym (locker rooms, showers, gang bathrooms), PAC (Performing Arts Center), & some classrooms. It is recommended to add a full-sized reduced pressure backflow preventor to each service to protect the town & the school's water from possible backflow.

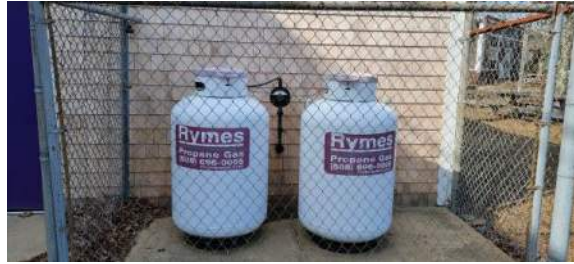
**(2) Propane tanks to feed kitchen equipment for Culinary kitchen.**

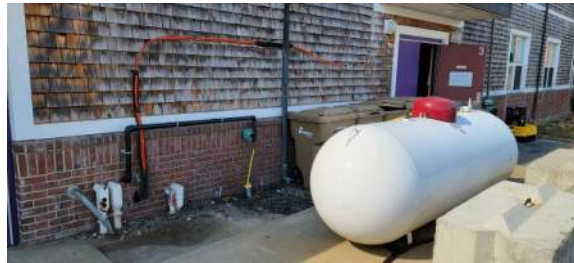
**Propane tank located outside of original Mech room which feeds new instantaneous propane fired domestic water heaters.**

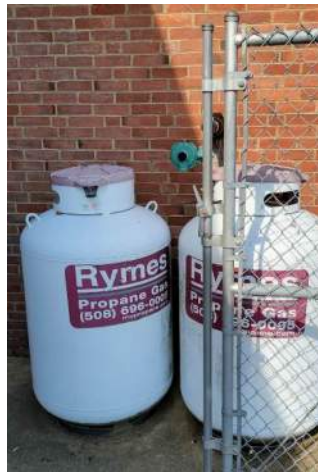
**(2) Propane tanks to feed kitchen equipment for Main kitchen.**

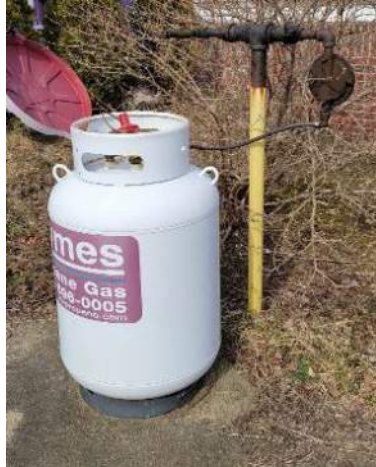
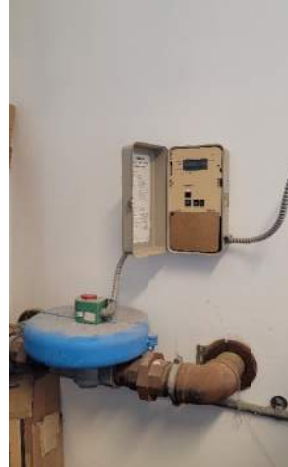
**Single Propane tank to feed Gas turrets in Science classrooms, along with a main gas shut off.**

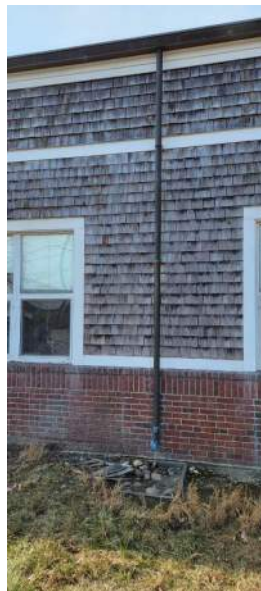
4. The school consists of mostly sloped roofs with a few portions of the school that have flat roofs which include the gym, auditorium, automotive & Carpentry shops.
5. Gutters are provided at sloped roof locations, were there is downspouts from gutters they spill to grade. It is recommended downspouts are piped to an underground storm system to direct the water away from the school.

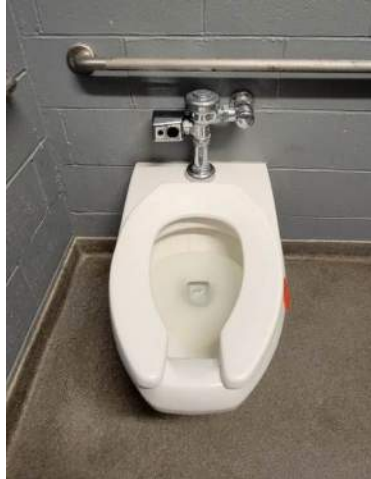
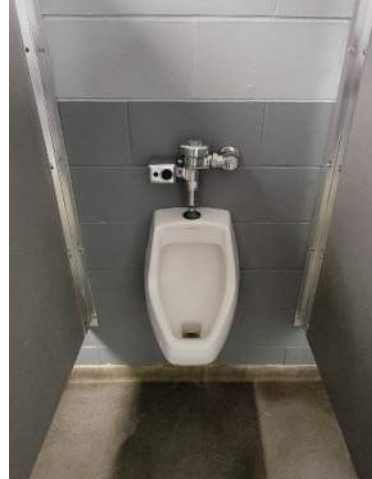
1. Bathrooms have wall hung vitreous china water closet and urinals with sensor flush valves and are in fair condition.

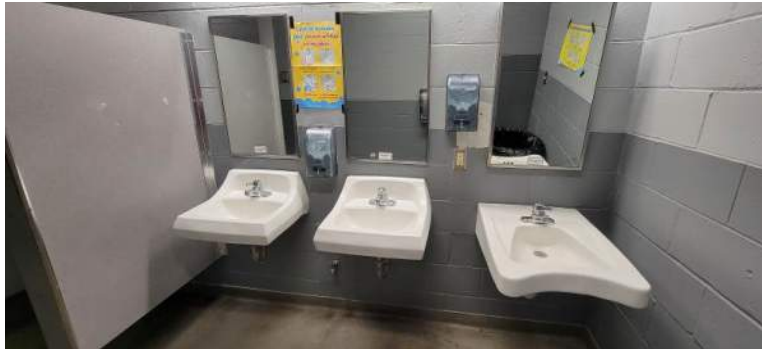
2. Bathrooms Lavatories are wall hung, vitreous china with manual metering faucets in fair condition.

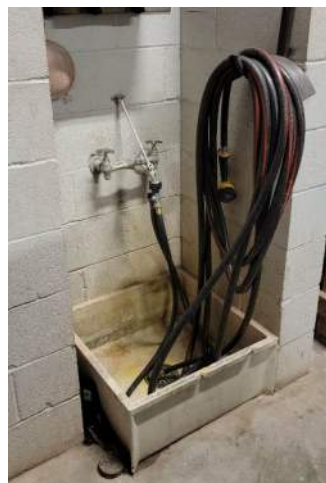
3. Mop service sinks are Fiat molded stone mop service basin fitted with faucet having threaded connection and vacuum breakers

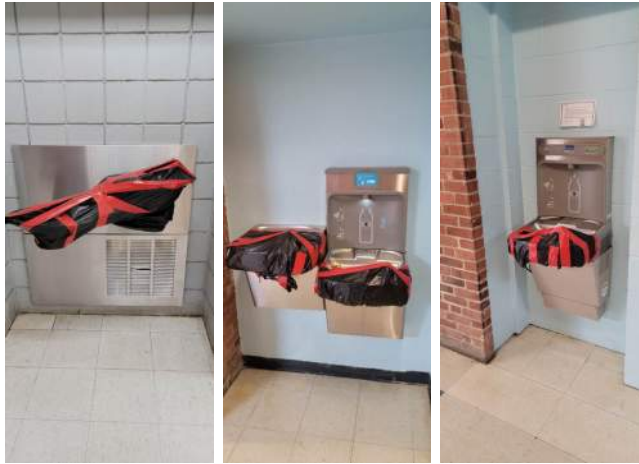
4. Drinking fountain are a mixer or different brands and styles depending on location in school. All are not in use and taped off due to current Covid-19 Pandemic.

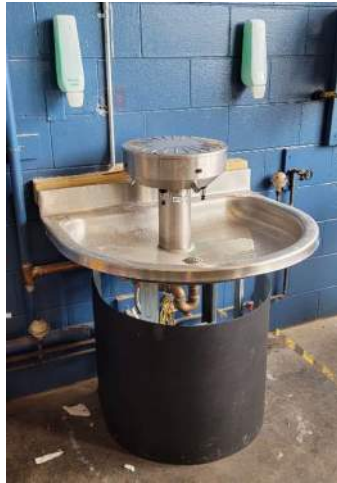
3. sensor operated stainless steel sink located in automotive sink in fair condition.

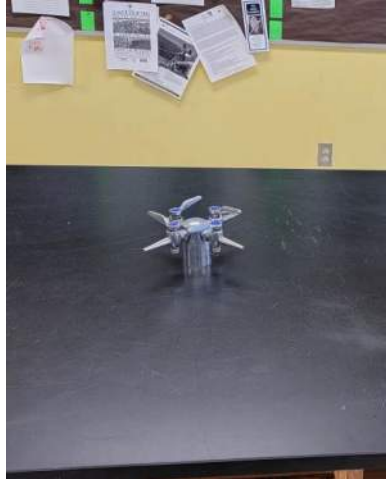
1. Each of the science classroom are provided with deck mounted LP gas turrets.

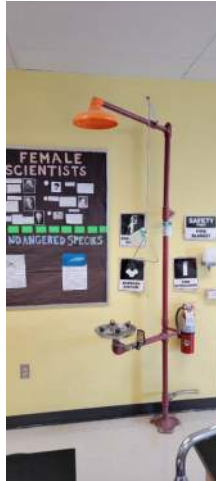
2. The Science Classrooms include an emergency shower and eyewash station.

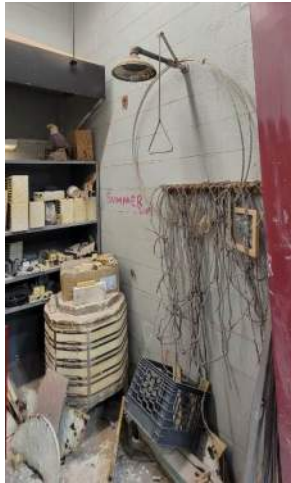
2. Located in Storage / Kiln room of art classroom is an emergency shower. it is unknown if this emergency station is functional, and is useable in the current state due to items being stored under it.

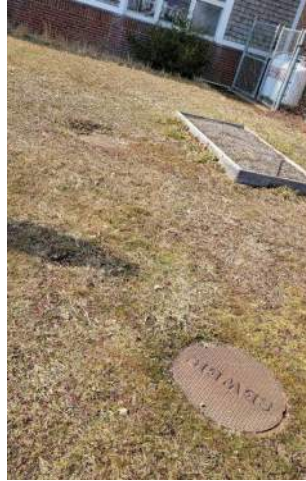
1. Main kitchen is located in original portion of school and appears all fixtures are piped to an exterior grease interceptor located just outside kitchen. The size is unknown.

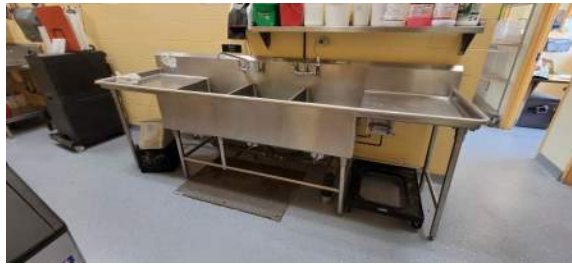
2. 3 pot sink with recessed grease interceptor located below.

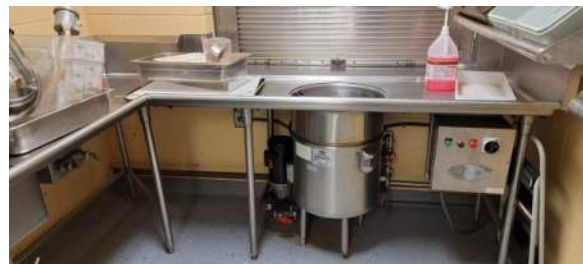
Food disposal system

3. Main kitchen has commercial grade dishwasher provided with electric booster heater, and food disposal system. no grease interceptor was found to be associated with this dish washer.

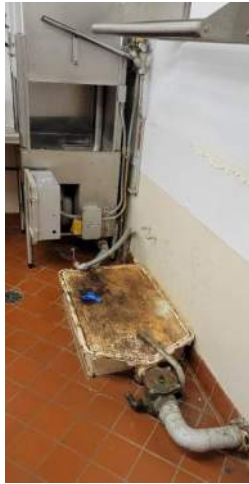
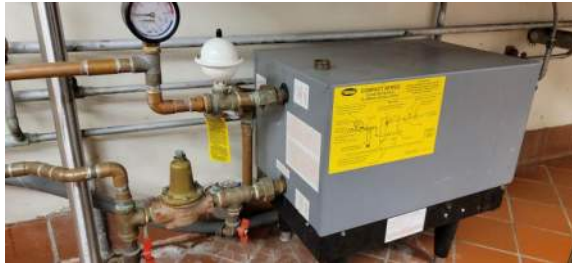
1. The Culinary is located in 1980's portion of school. It is unknown if this kitchen was tied into the main exterior grease interceptor located in the original school, and if the existing grease interceptor was replaced to handle the load of both Kitchens & Extra meals being prepared.
2. There is a smaller commercial grade dishwasher located in the culinary kitchen with associated Electric booster heater & grease interceptor.

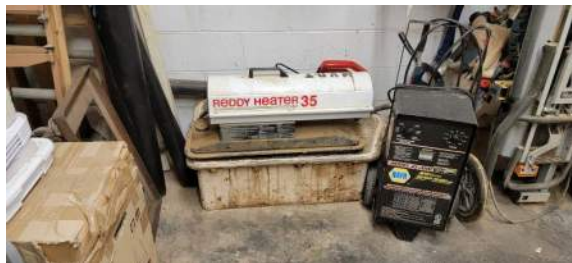
3. The 3 pot sink located in the culinary kitchen goes to a grease interceptor which is located in the storage room of the carpentry shop.

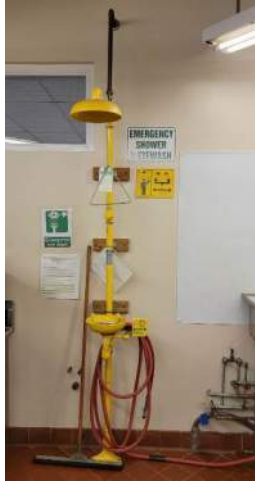
4. Located in the Culinary kitchen is an Emergency Shower/Eyewash station.

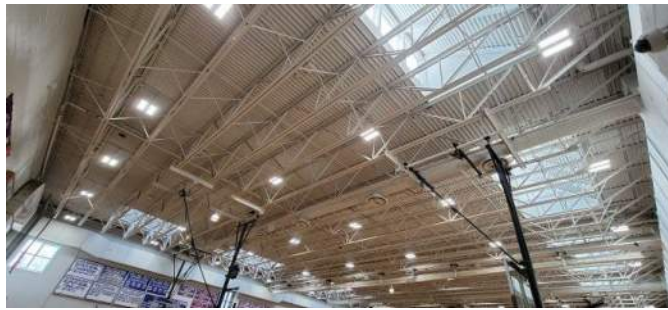
1. The gym roof is one of the few flat rooms in the school and is drained by roof drains.

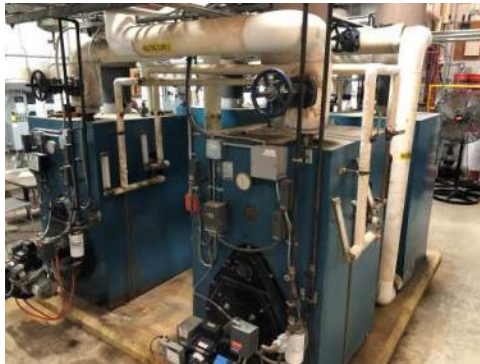
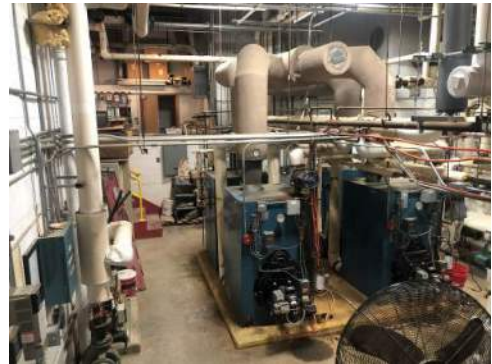
**1959 Boiler Room**

The 1959 boiler room has (4) four oil fired boilers manufactured by Burnham Corporation boiler model FF-506. The boilers are 6-section cast iron standard efficiency having an input capacity 8.3 GPH and an output capacity of 827 MBH. For a total output plant capacity of 3,308 MBH. The boilers are equipped with Carlin oil fired burners model 702CRD having an input capacity of 8.3 GPH.

The boilers provide hot water for heating the 1959 portion of the building which is circulated by two sets of pumps (four pumps total). Each set is arranged in a primary/stand-by configuration. The boilers and pumps appear to be in good shape for the age. Some of the motors on he pumps have been replaced, unable to tell how old they are.

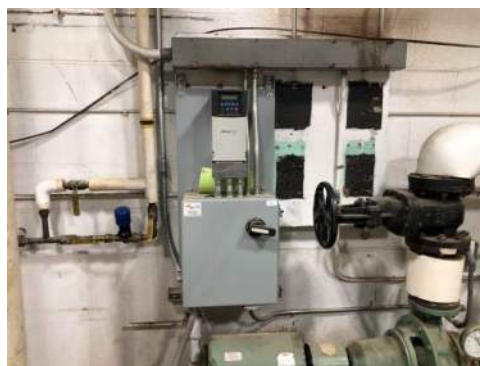
### **Pump VFDs**

The pumps are equipped with variable frequency drive (VFDs). The VFDs have been placed in hand mode and do not react to system pressure changes in the system.

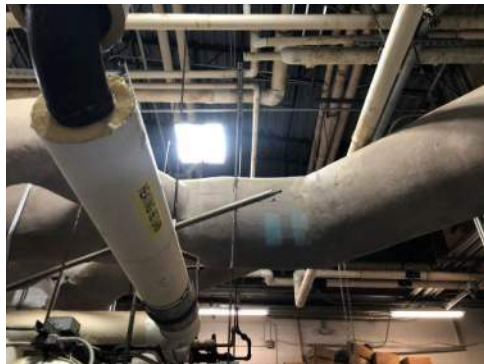
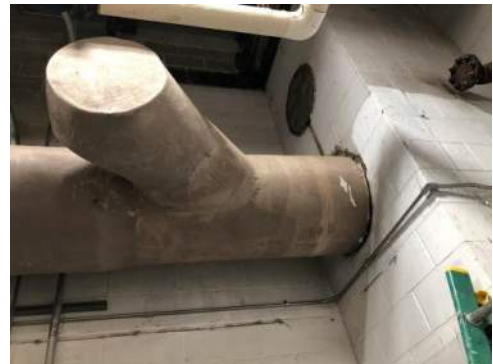
**Boiler Breeching**

Products of combustion exit the building thru an insulated galvanized steel breeching. The galvanized breeching extends about 10'-0" above the finished roof.

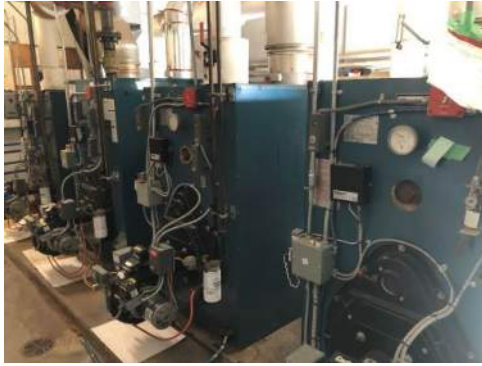
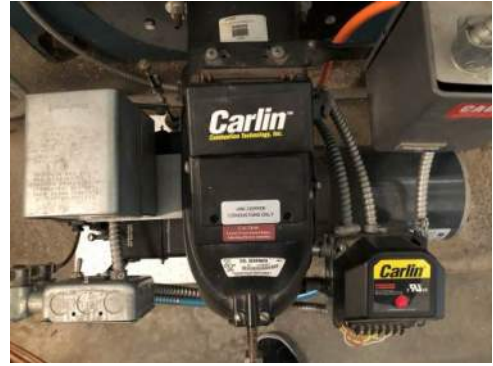
**1990 Boiler Room**

The 1990 boiler room has (4) four oil fired boilers manufactured by Burnham Corporation boiler model FF-509. The boilers are 9-section cast iron standard efficiency having an input capacity 12.6 GPH and an output capacity of 1257 MBH. For a total output plant capacity of 5,028 MBH. The boilers are equipped with Carlin oil fired burners model 801CRD having an input capacity of 12.6 GPH.

The boilers provide hot water for heating the 1990 portion of the building which is circulated by two sets of pumps (four pumps total). Each set is arranged in a primary/stand-by configuration. The boilers and pumps appear to be in good shape for the age. Some of the pump motors have been replaced, unable to tell how old they are.

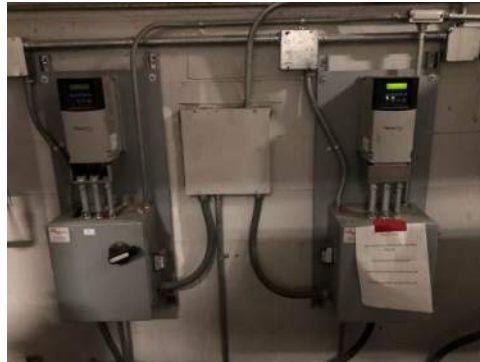
**Pump VFDs**

The pumps are equipped with variable frequency drive (VFDs). The VFDs have been placed in hand mode and do not react to system pressure changes in the system.

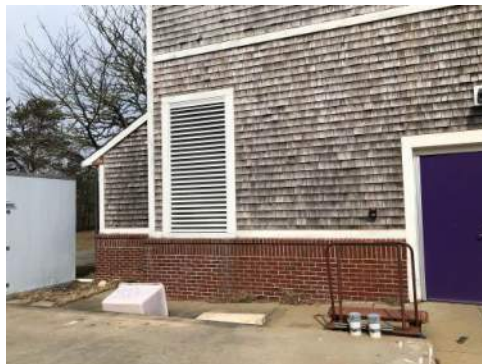
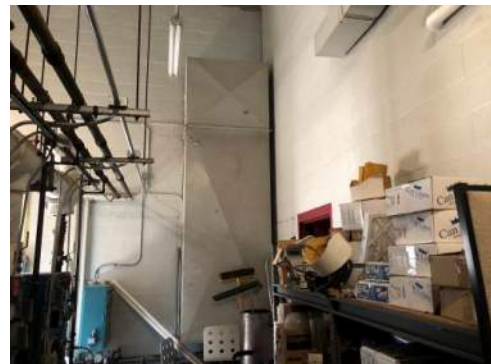
**Combustion Air Intake**

Combustion air is brought into the building by a wall louver with ductwork. The combustion air exits the ductwork about 12" above the finished floor. There is no high vent which is required by code.

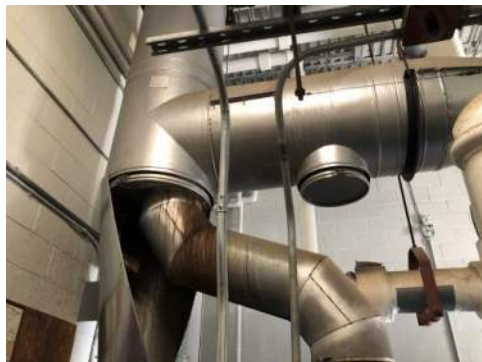
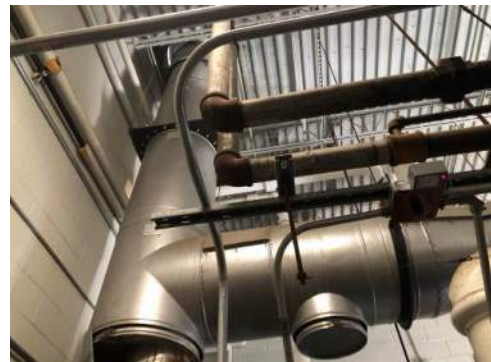
## Boiler Breeching

Products of combustion exit the building thru galvanized steel breeching with aluminum shell. The breeching extends about 10'-0" above the finished roof.

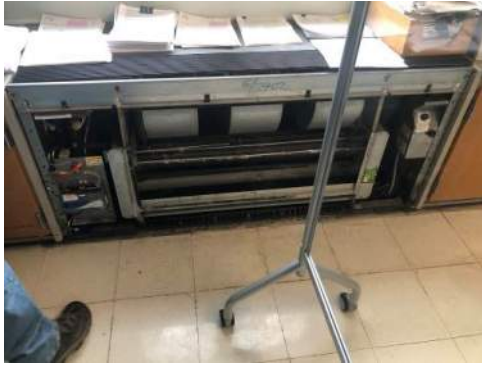
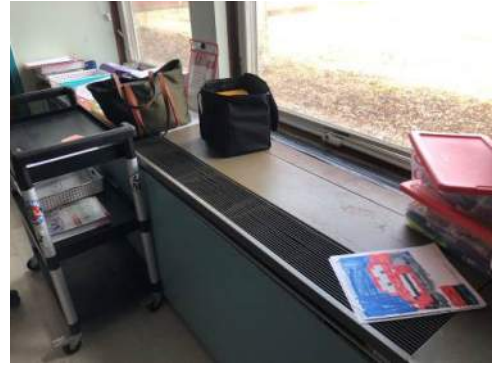
**Classroom Unit Ventilators**

Classrooms are heated and ventilated by classroom unit ventilators. Outside air is supplied to the unit ventilators via wall louvers located below the windows. Each unit ventilator has a hot water coil, filters, outside/return air dampers and supply fans. Valve and damper actuators are direct digital control. The classroom unit ventilators were manufactured by American Air Filter and appear to be installed during the 1990 addition/renovation. The unit ventilators appear to be in good shape for their age but are close to the end of their useful service life.

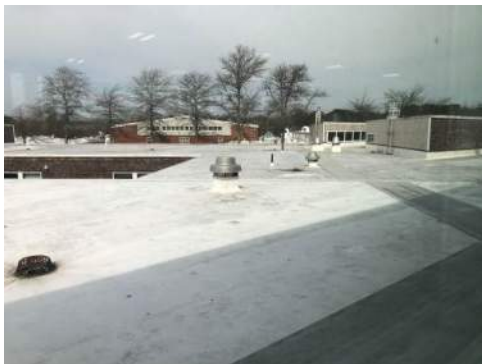
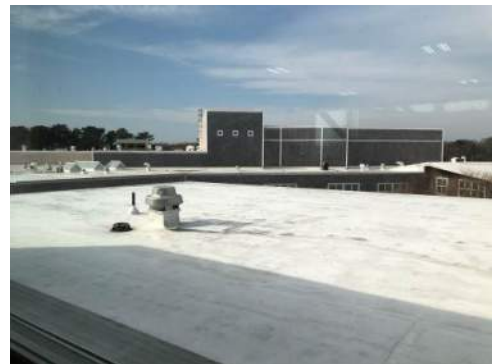
**Roof Mounted Exhaust Fans**

General exhaust for the classrooms is provided by a system consisting of ceiling exhaust grilles, ductwork and roof exhaust fans. The exhaust fans appear to be in good shape for their age but are close to the end of their useful service life.

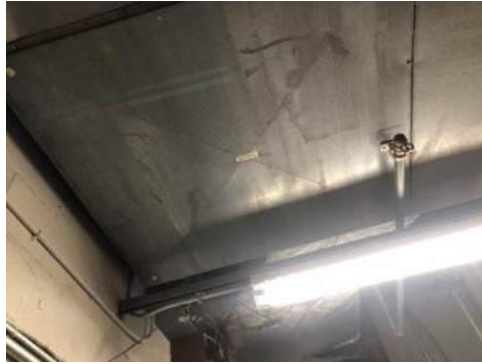
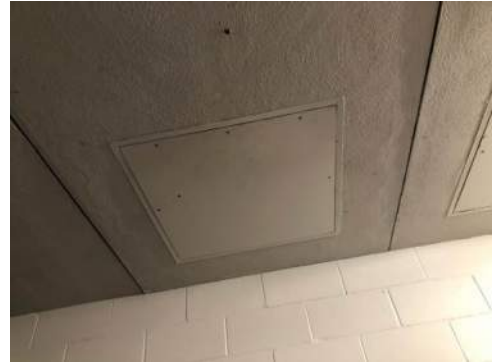
**Gym AHU Located in Storage Room and Above Locker Room Ceiling**

The gymnasium is heated and ventilated by two (2) central station air handling units. Located above the ceiling in the gymnasium storage room and locker rooms. Each unit serves one half of the gym with overhead ductwork and diffusers. The air handling units are original, these systems have outlived their useful service life. The units are difficult to service and would be close to impossible to replace unless hard ceiling and/or portion walls were removed. Access to the units is through 24"x24" access doors. Most components in the AHU are bigger than the 24"x24".

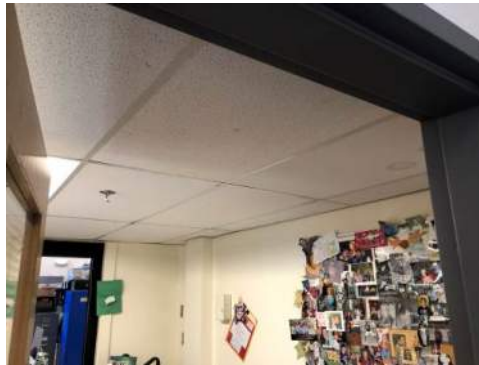
**Location of AHU Above Ceiling**

The kitchen and cafeteria are heated and ventilated by a single central station air handling unit. Located above the ceiling in an adjacent office space. The unit serves the kitchen and cafeteria with overhead ductwork and diffusers. The air handling unit is original, these systems have outlived their useful service life. The unit is difficult to service being placed above a section of ceiling in an adjacent office. Access to the unit is through the atc grid requiring a tall ladder to get access to the unit.

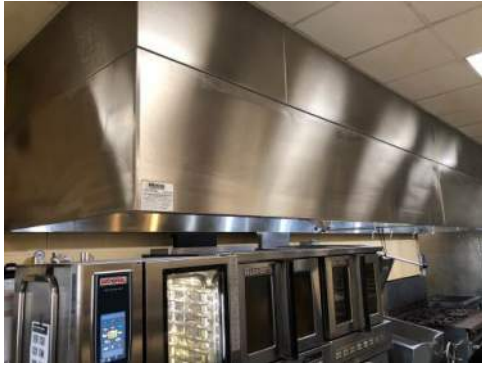
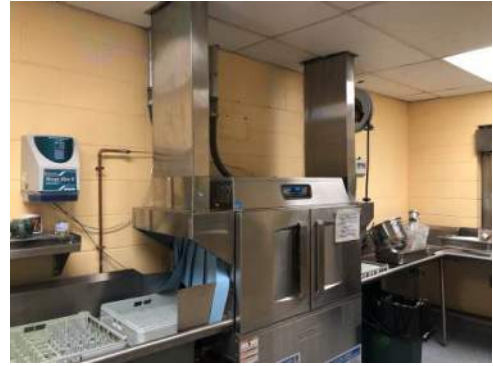
**Kitchen Hood & Dishwasher Exhaust**

The kitchen is equipped with a kitchen hood and dedicated exhaust. Make-up air for the kitchen hood is from the single central station air handling unit serving the kitchen and cafeteria.

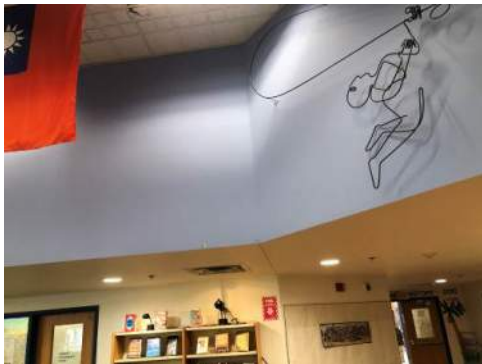
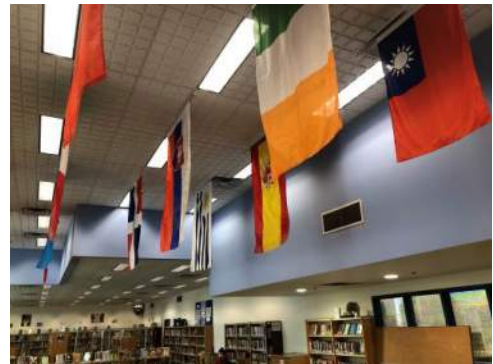
**Location of AHU Above Ceiling**

The Media Center is heated, cooled and ventilated by a single central station air handling unit. Located above the ceiling in the Media Center. The unit serves the Media Center with overhead ductwork and diffusers. The Media Center has perimeter fin tube wrapping the exterior walls. Air condition is provided by a remote air-cooled condenser located outside the Media Center. The air handling unit and air-cooled condenser appear to be original; these systems have outlived their useful service life. The unit is difficult to service being placed above section of ceiling in the Media Center. Access to the unit is through the atc grid requiring a tall ladder to get access to the unit.

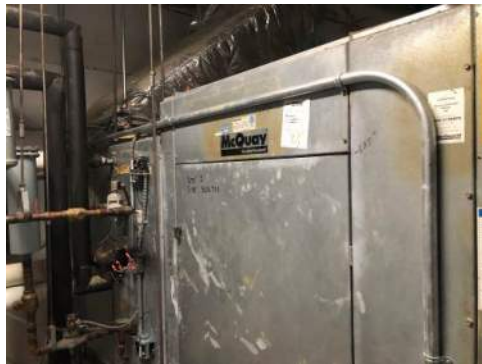
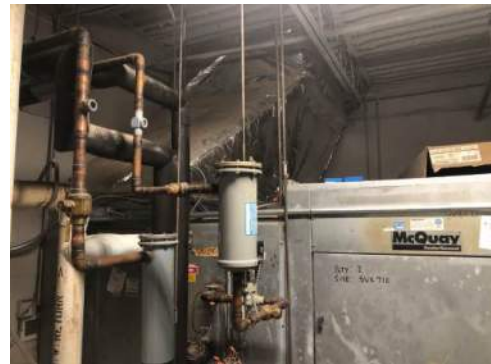
**AHU serving Performing Arts Center**

The Performing Arts Center is heated, cooled and ventilated by a single central station air handling unit. The unit is located in a machine room above on of the electrical closets. The unit serves the Performing Arts Center with overhead ductwork and diffusers. The air handling unit is original, the system have outlived their useful service life. The unit is located on a mezzanine which allows for easy service access to the unit. However, the opening to gain access to the unit is small. The access opening is not large enough to rig in or removed large components of the air handling unit. To replace the unit a large opening would need to be created either in the floor or at one of the portion walls.

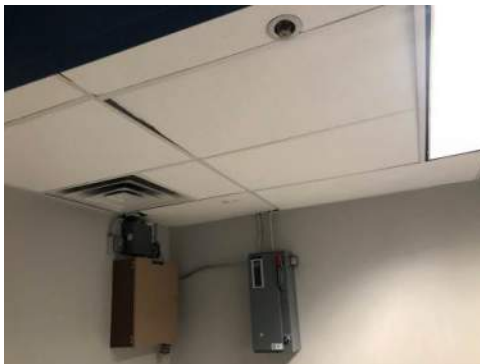
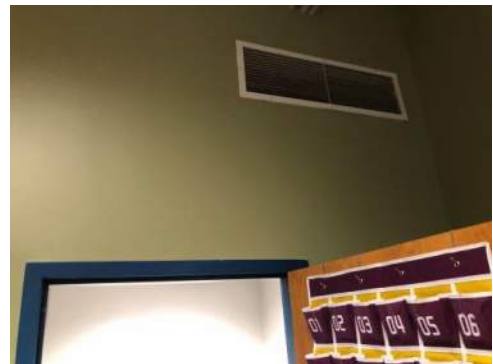
### **AHU Located Above Ceiling**

The Administration Clusters are heated, and ventilated by central station air handling units. The units are located above the ceilings in their respected administration cluster. The units serve the Administration Wings with overhead ductwork and diffusers. The air handling units are original, these systems have outlived their useful service life. The units are difficult to service being placed above section of ceiling in the in each Administration cluster. Access to the units is through the atc grid requiring a tall ladder to get access to the units.

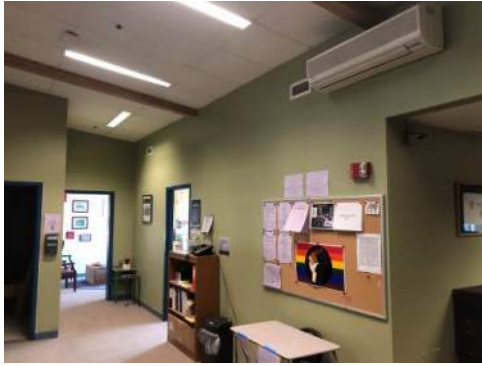
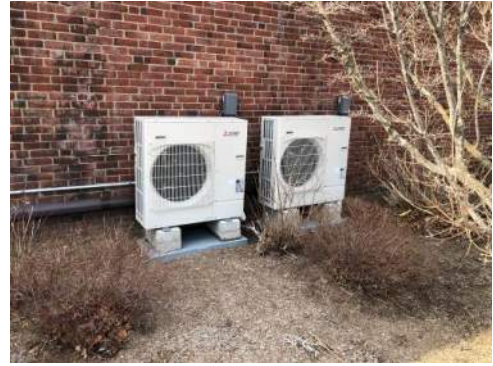
**Indoor Ductless Cooling Unit and Outdoor Remote Condenser**

Ductless wall mounted cooling units have been added to the administration clusters to provide air conditioning. The wall units are centrally located within the common space within each cluster. Individual offices do not have dedicated equipment providing air conditioning. Condition air comes from the centrally located ductless wall unit.

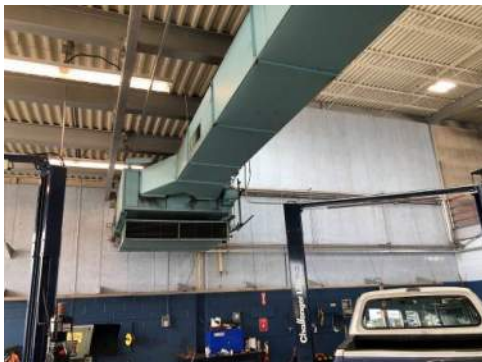
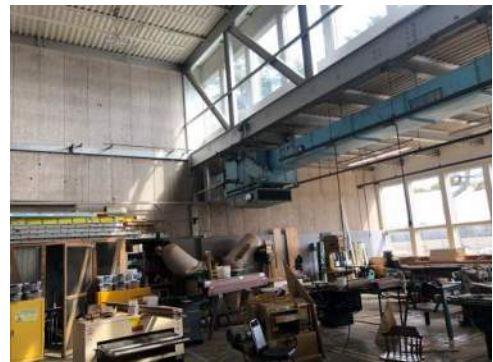
**AHU located in Automotive and Carpentry Shops**

The Automotive and Carpentry shops are heated and ventilated by indoor central station air handling units. The units are located within the space they serve. The air handling units are original, these systems have outlived their useful service life. Access to the units for service is not restricted but does require ladders.

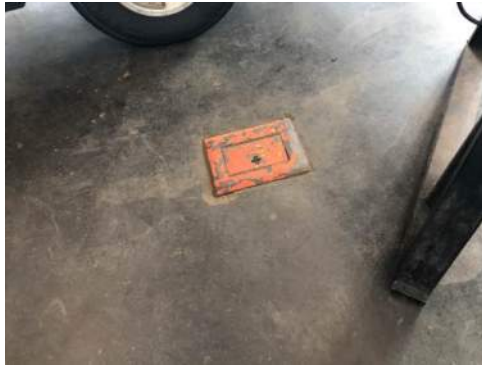
### **Vehicle Exhaust Capture System**

The automotive shop is equipped with vehicle exhaust capture system. The ports are located in the floor with flap covers to prevent debris from getting into the system. The ductwork runs below the slab to a duct riser and exhaust fan exiting the building at the mezzanine level of the shop.

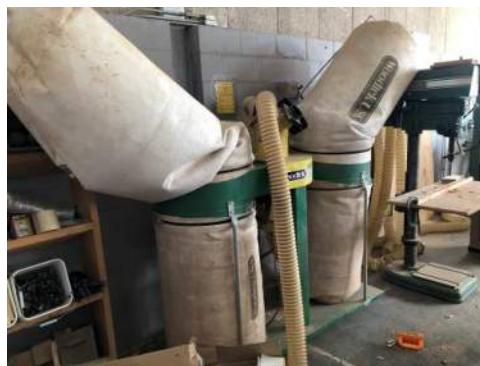
### **Indoor Dust Collection System**

The carpentry shop is equipped with a dust collection system. The dust collection system is located indoors and does not meet today standard and safety requirements. At the time of the visit, we informed that a new outdoor dust collection system was in the works.

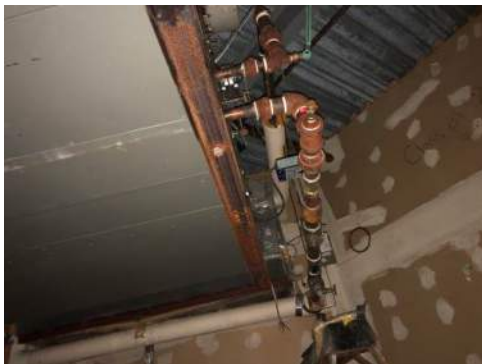
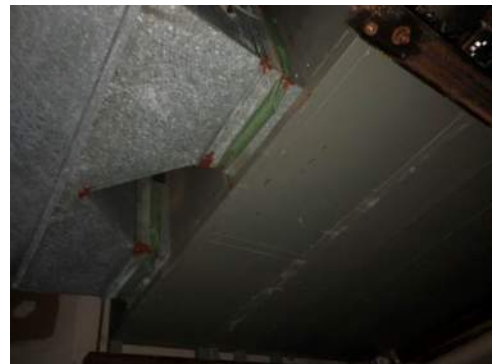
The Kitchen shop is heated and ventilated by indoor central station air handling units. The unit serves the Kitchen Shop with overhead ductwork and diffusers. The unit also provides make-up air for the kitchen hoods. The air handling unit is original, and has outlived its useful service life. The unit is located in a small machine room above a small closet in the dishwasher room. The opening to gain access to the unit is small. The access opening is not large enough to rig in or removed large components of the air handling unit. To replace the unit a large opening would need to be created either in the floor or at one of the partition walls.

**AHU Located Above Storage Room**

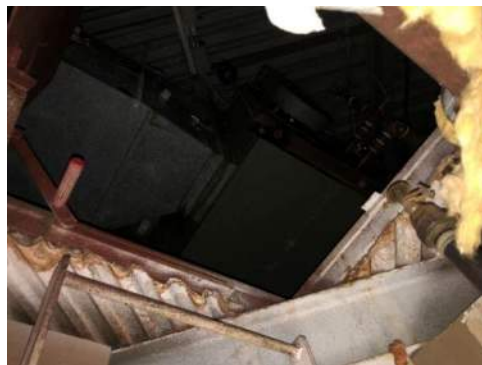
**Access Point to AHU**

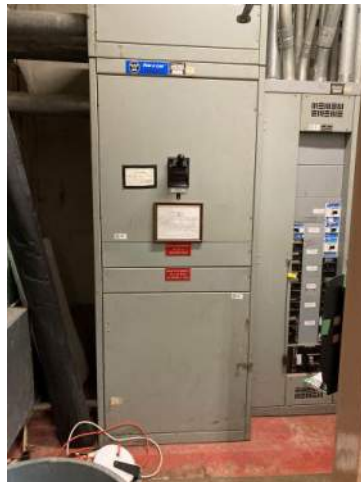
**Switchboard 1**

The switchboard as manufactured by Westinghouse is rated for 120/208v, three phase, four wire, 2000 amp and has a 2000/3 main breaker, a 1000/3 breaker which feeds Switchboard 2 and branch panel breakers. The Main Electric Room does not have proper working space and dedicated electrical space as required by the National Electric Code, as it relates to the switchboard. The switchboard appears to have been installed when the 1980's addition was built and is in fair condition.

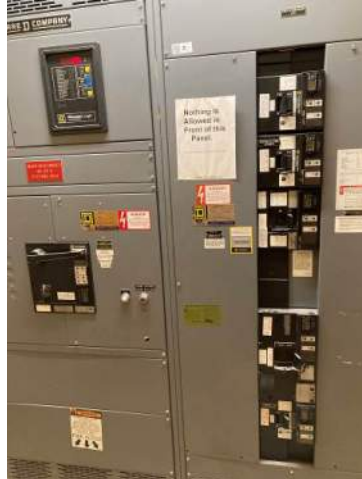
**Switchboard 3**

The switchboard as manufactured by Square D is rated for 277/480v, three phase, four wire, 2000 amp and has a 2000/3 main breaker, a 400/3 breaker which feeds the automatic transfer switch in the generator enclosure, the Performing Arts Center, and the horticultural center / football field. The switchboard appears to have been installed when the 1990's addition was built and is in good condition.

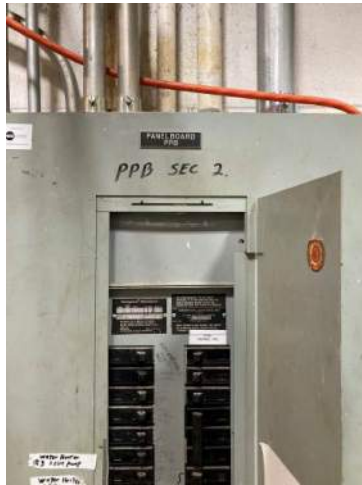
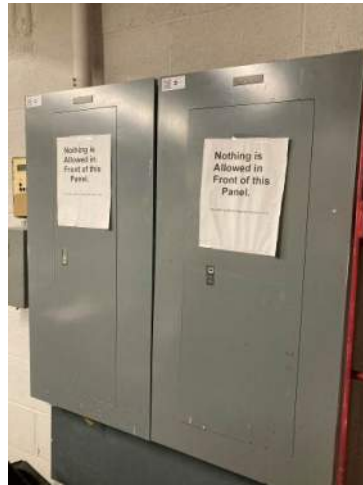
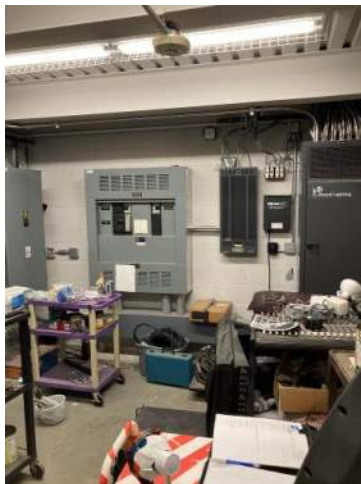
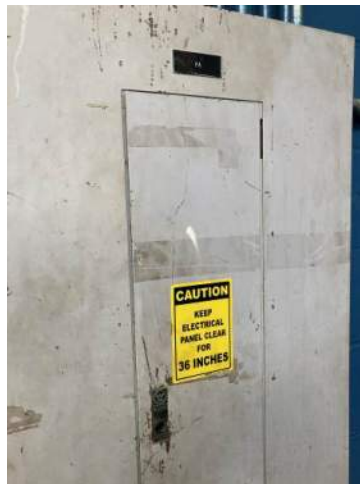
**Panelboard Samples**

motor equipment, there are mushroom type buttons for shutting down power upon an emergency condition. The Kitchen panelboards do not appear to have shunt trip circuit breakers capable of tripping power to kitchen equipment under the hood upon fire alarm activation. The normal power distribution appears to be original to the building, as well as the 1980's and 1990's addition and is in fair condition.

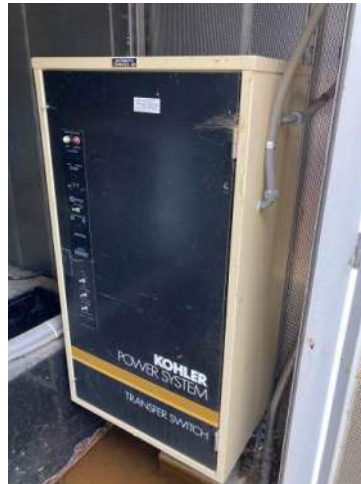
**Automatic Transfer Switch**

phase, four wire. The load side of the automatic transfer switch feeds the emergency distribution panelboard EDP, also located in the generator enclosure. Panelboard EDP feeds adjacent panelboard EL via a transformer, both of which are located in the generator enclosure, panelboards B-H, PP-B, LP-B, KP-B, as well as AHU's 8 and 10. These panelboards feed mixed emergency loads including both optional standby and emergency circuits. There are numerous emergency system deficiencies as it relates to current Codes. There is only one automatic transfer switch which controls both emergency life safety and optional stand by loads. Emergency panelboards need to have dedicated two hour rated emergency electric rooms and cannot share space with optional standby and normal panelboards. Emergency panelboards require two-hour feeders such as MI Cable and are required to be housed in two-hour electric rooms. Emergency panelboards have to be dedicated to emergency loads and cannot feed optional standby loads within the same panelboard. The emergency power distribution appears to be original to the building and the installation as it relates to today's Codes is poor. Also, there was 3-4 inches of water in the bottom of the generator enclosure which is a hazard to staff as well as the equipment. The generator system is in poor condition.

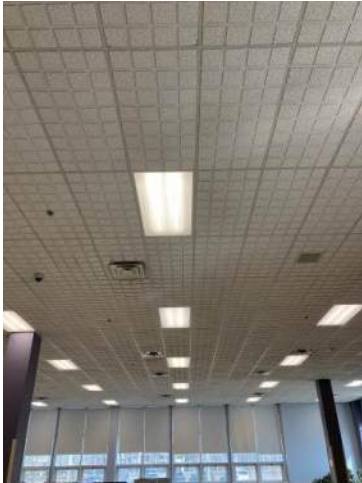
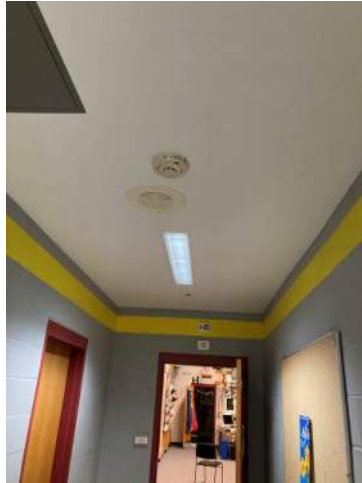
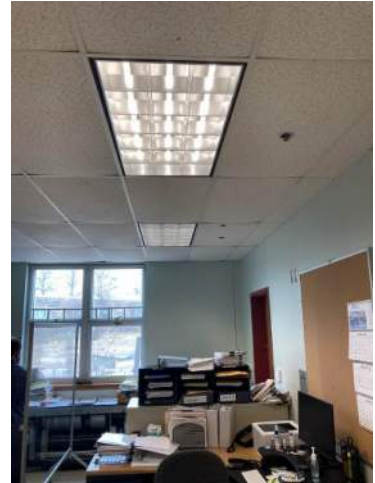
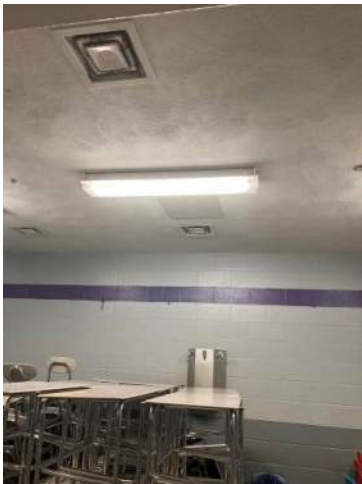
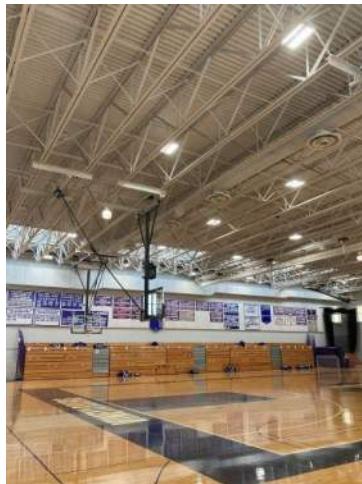
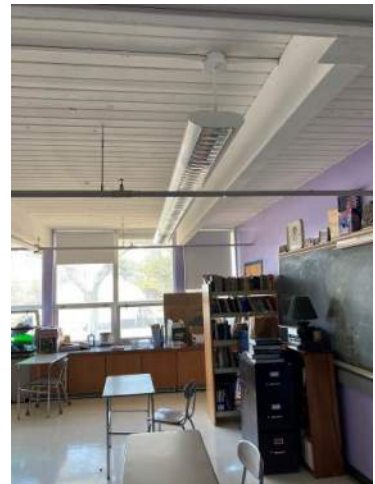
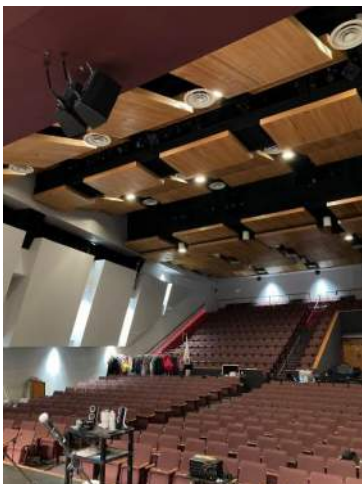
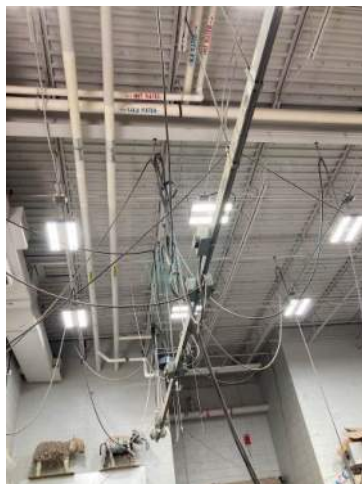
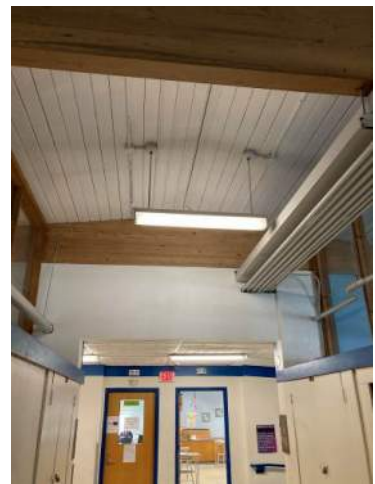
**Samples of Interior Lighting Fixtures**

Staff indicated that the original lighting fixtures were replaced with new or existing was retrofitted with new T8 lamps, via electric utility co. program. Interior lighting is made up of dust moisture resistant, wraparounds, parabolic, prismatic, industrials, strips, wall brackets, linear pendants, industrial high bays with T8 lamps; downlights, pendant cylinders, and wall sconces, with high intensity discharge lamps; and track lighting. Exit signs provide for direction to paths of egress. Deficiencies of interior lighting include improper coverage of exit signage and some exit signage not functioning. Lighting is not the most efficient as it relates to today's standards. The interior lighting appears to be in fair condition.

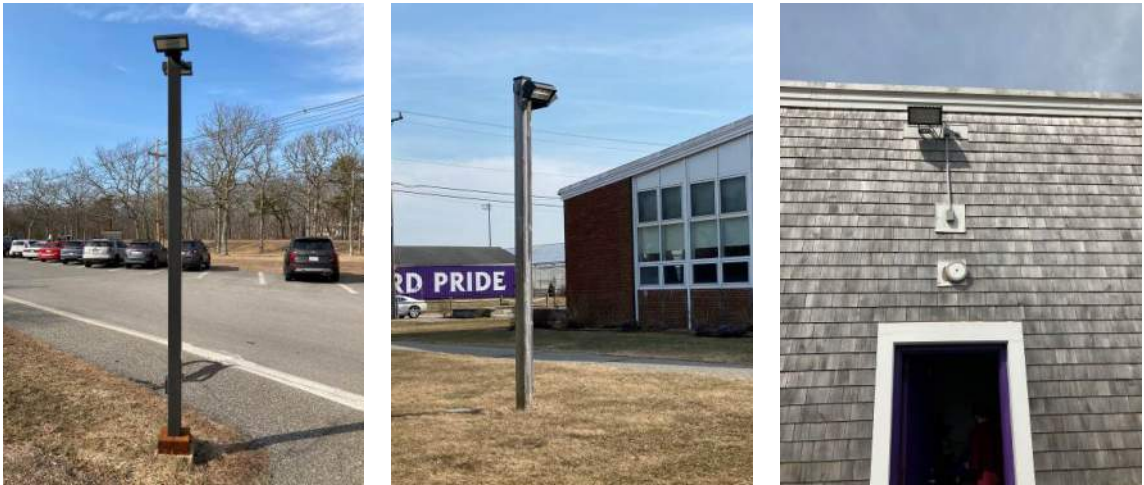
Lighting is made up of mostly wall packs which were replaced in 2019 with LED fixtures. The original parking lot poles have been retrofitted with LED heads back in 2019. The building mounted exterior lighting fixtures as well as the replacement pole mounted fixture heads appears to be in good condition. The poles supporting the parking lot LED heads appear to be in fair condition.

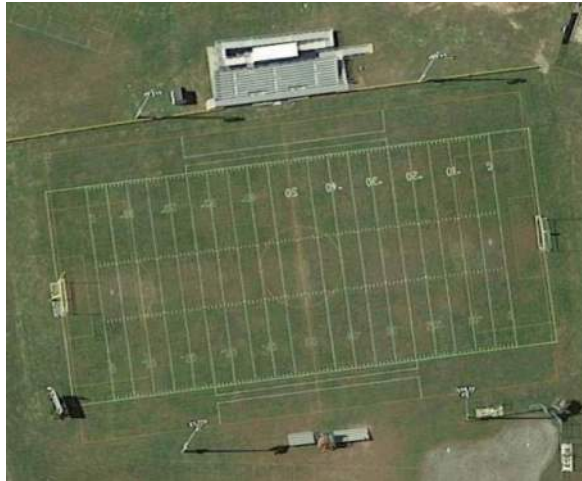
**Football Field with Sports Lighting**

The football stadium is lit through the use of sports lighting poles with sports lighters. There are a total of four poles with lighters. Lamps are likely between 1,000 and 1,500 watts each. The tennis courts are no lit. The football stadium sports lighting appears to be in fair condition.

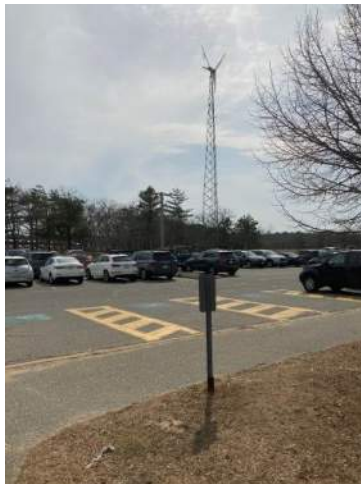
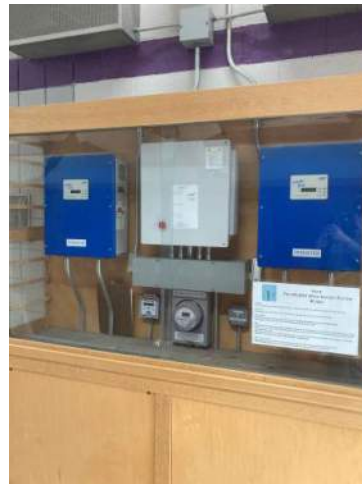
**Wind Turbine and Control Equipment**

There is an existing wind turbine on site which is currently non-operational. The controls are interior of the building and are non-operational as well. It was indicated that at some point the turbine will be fixed and made operational, but it is not a priority to have this work done.
